Manhole Inspection Summary

Manhole # S01WW1005MH

Insp Date: **7/28/06 10:31 AM**

Location Address: **6200 Pinkey Rd**

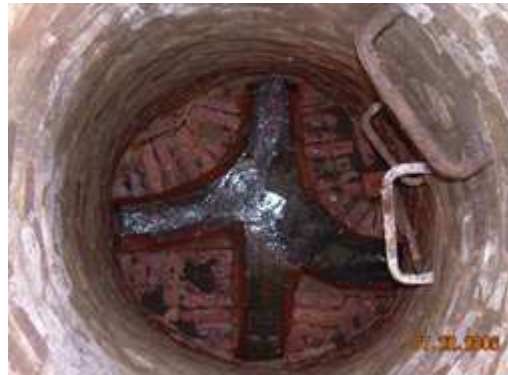
Top View

Condition: ☐ Sound ☐ Cracked ☐ Root Intrusion ☒ **Loose Brick** ☐ Deteriorated

Infiltration: ☐ None ☐ Joint ☐ Cracks ☐ Mortar ☐ Roots ☒ **Wall**

Condition: ☐ Sound ☐ Cracked ☐ Root Intrusion ☐ Deteriorated ☐ Leaks ☒ **Debris**

Count: **4** Missing: **0** ☒ **Corroded**

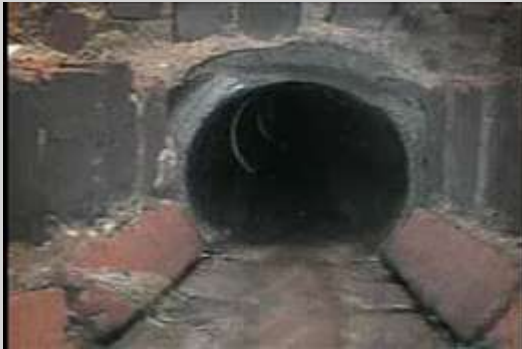
8 in. Circular Gravity Sewer Pipe Out @ 12 O'Clock

Pipe Material: **Clay** ☐ Pipe Lined

Invert Depth: **9.37** (ft.) Flow Characteristics: **Slow**

Deposits: ☒ None ☐ Mud ☐ Sludge ☐ Debris ☐ Grease

Infiltration: **None** Pipe Seal Cond: **Sound**

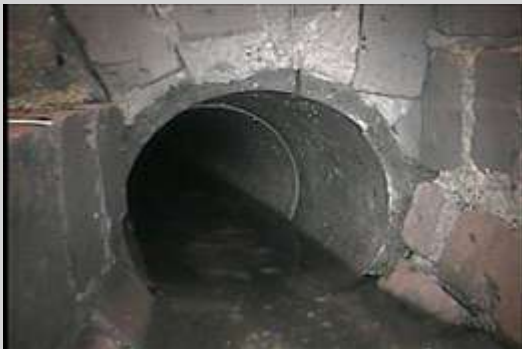
8 in. Circular Gravity Sewer Pipe In @ 3 O'Clock

Pipe Material: **Clay** ☐ Pipe Lined

Invert Depth: **9.37** (ft.) Flow Characteristics: **Slow**

Deposits: ☒ None ☐ Mud ☐ Sludge ☐ Debris ☐ Grease

Infiltration: **None** Pipe Seal Cond: **Sound**

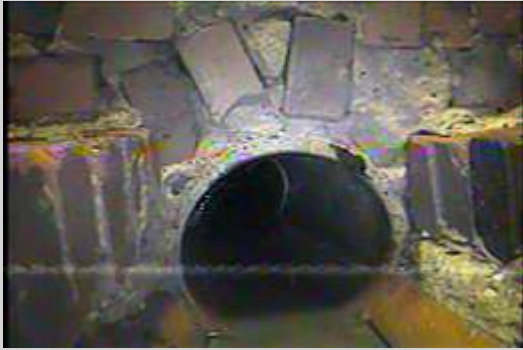
Pipe In @ 6 O'Clock

Pipe Material: **Clay** ☐ Pipe Lined

Invert Depth: **9.35** (ft.) Flow Characteristics: **Slow**

Deposits: ☒ None ☐ Mud ☐ Sludge ☐ Debris ☐ Grease

Infiltration: **None** Pipe Seal Cond: **Sound**

Connects To: **Dead End**

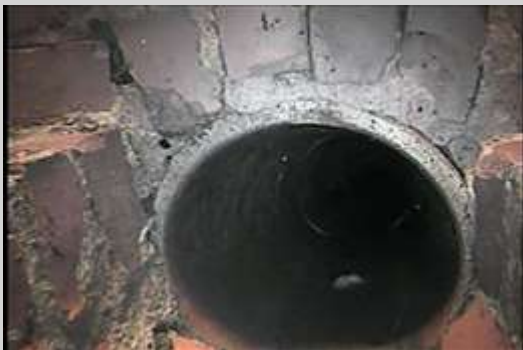
Pipe In @ 9 O'Clock

Pipe Material: **Clay** ☐ Pipe Lined

Invert Depth: **9.14** (ft.) Flow Characteristics: **Slow**

Deposits: ☒ None ☐ Mud ☐ Sludge ☐ Debris ☐ Grease

Infiltration: **None** Pipe Seal Cond: **Sound**
